# prairieview golf club

## Turf Notes from the Turf Care Center

### *Bunker Renovations Complete on 15th Hole*

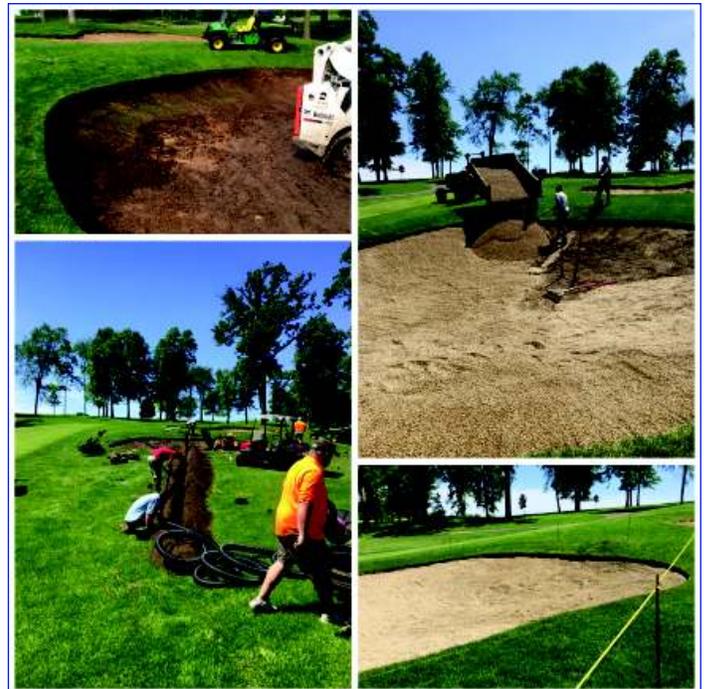
The Better Billy Bunker system involves the application of a polymer spray that is applied over the top of an evenly spread 2" layer of pea gravel. This combination dries to form a solid but permeable surface that will allow water to easily pass through and exit the bunker through the subsurface drainage tiles. Twenty-four hours after application, sand

To complete the renovation and test bunkers on the 15th hole, we chose to implement the Better Billy Bunker method in reconstructing the bunkers. The key to success of any bunker renovation is being able to provide sufficient drainage and the ability to keep sand in place on the flashed slopes of the bunker. Initially, a cloth liner like the Sand Trapper, was used as a synthetic liner to allow the water to pass through while keeping the sand in place. Over the years, staples used to hold the liner down would come loose and soon be caught by the machine raking the trap. The result is a compromised liner that would soon no longer do the job it was intended to do. At PrairieView, our bunkers were constructed following the standard method at the time, which was simply sand placed on top of the native soil with no lining system in place. That method has proven to provide an average of a 7-10 year lifespan. Our bunkers are in their 25th season and many are in need of a renovation. The most recent technology is the Better Billy Bunker, which has installations that are going on 10 years old that are still performing as advertised.

is able to be reinstalled and the project is complete. These two traps are about as maintenance free as they can get. You may notice that initially these traps will play much softer than others on the course. This is due to new sand being installed. The sand we are using is an exact match to what exists in all the other bunkers. The only difference is sediment contamination that has occurred over the past 25 years in the other bunkers. As the two renovated bunkers mature, the sand will continue to firm up and more closely match the existing bunkers throughout the course. Throughout the end of the 2016 season, we will be monitoring the success of the project and hope to continue renovating other problem bunkers in 2017 and beyond. If you have any questions about this project or anything else happening out on the course, feel free to give me a call at 815-234-8535 ext. 211 or by e-mail at [matt@prairieviewgolf.com](mailto:matt@prairieviewgolf.com). You can also stay up to date on what we are doing by following my twitter feed @mph\_turf79 for updates on ongoing projects.
